# Manhole Inspection Summary

Manhole # S25C\_\_039MH

**Location** Address: **501 FRANKLIN ST**

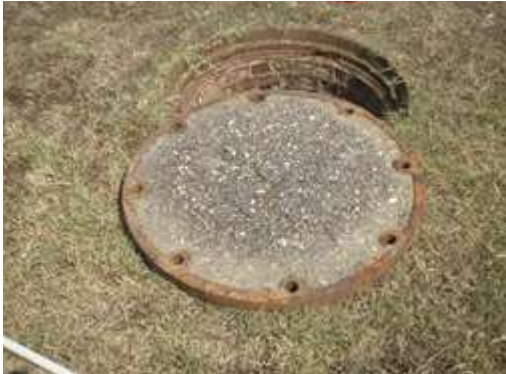
Defect 1

Type: **Conduit**

CONDUIT LID

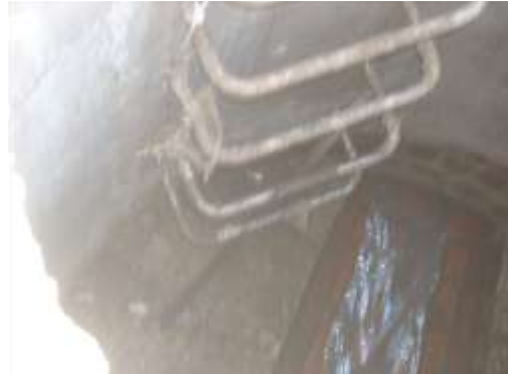
Defect 3

**Surcharge** ☒ **Evidence Of Surcharge** Depth: **2** (ft.) ☐ Active Surcharge Present

SURCHARGE EVIDENCE ON A STEP

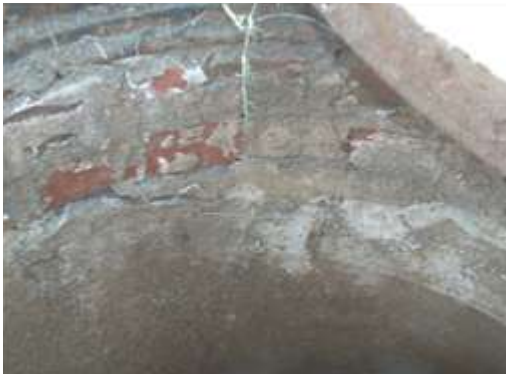
Defect 2

Condition: ☐ Sound ☐ Cracked ☐ Root Intrusion ☐ Loose Brick ☒ **Deteriorated**

DETERIORATED CORBEL

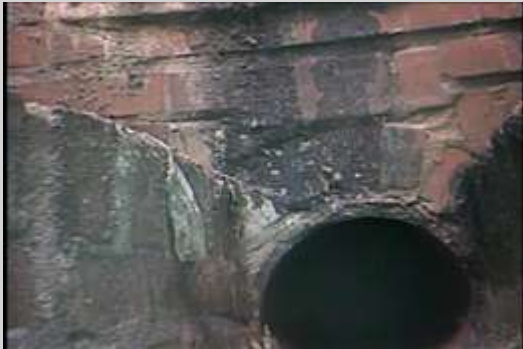
12 O'Clock Outflow

Pipe Height: **9.6** (in.) Rod and Bar (Angled)  
Pipe Material: **Clay** ☐ Pipe Lined  
Invert Depth: **10.54** (ft.) Flow Characteristics: **Fast**  
Deposits: ☒ None ☐ Mud ☐ Sludge ☐ Debris ☐ Grease  
Silt Depth: (in.) Deposits Extent:  
Infiltration: **None** Pipe Seal Cond: **Sound**

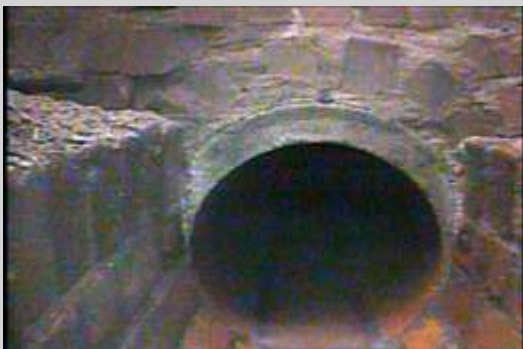
8 O'Clock Inflow

Pipe Height: **10.8** (in.) Rod and Bar (Angled)  
Pipe Material: **Clay** ☐ Pipe Lined  
Invert Depth: **10.05** (ft.) Flow Characteristics: **Fast**  
Deposits: ☒ None ☐ Mud ☐ Sludge ☐ Debris ☐ Grease  
Silt Depth: (in.) Deposits Extent:  
Infiltration: **None** Pipe Seal Cond: **Sound**
